Subj: USS MIAMI (SSN 755) FIRE PANEL RECOMMENDATIONS

**USS MIAMI (SSN 755)
Fire Review Panel**

1 October 2012

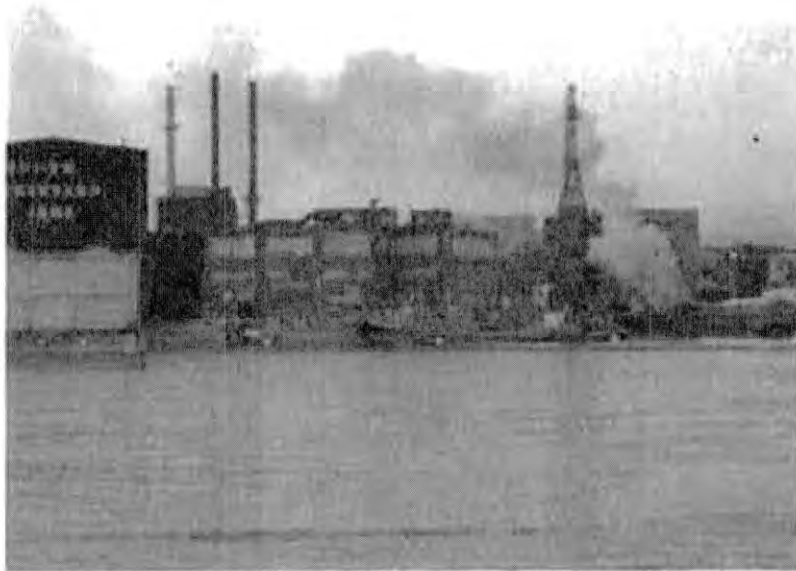
USS MIAMI (SSN 755) on the Evening of the Fire

On 23 May 2012, a fire broke out on board USS MIAMI (SSN 755) while in Drydock Number Two at PNSY in Kittery, Maine. A shipyard worker has confessed to starting the fire in Wardroom Stateroom (WRSR) 1 in Forward Compartment Middle Level (FCML). All times are stated in local (ZULU plus four) time.

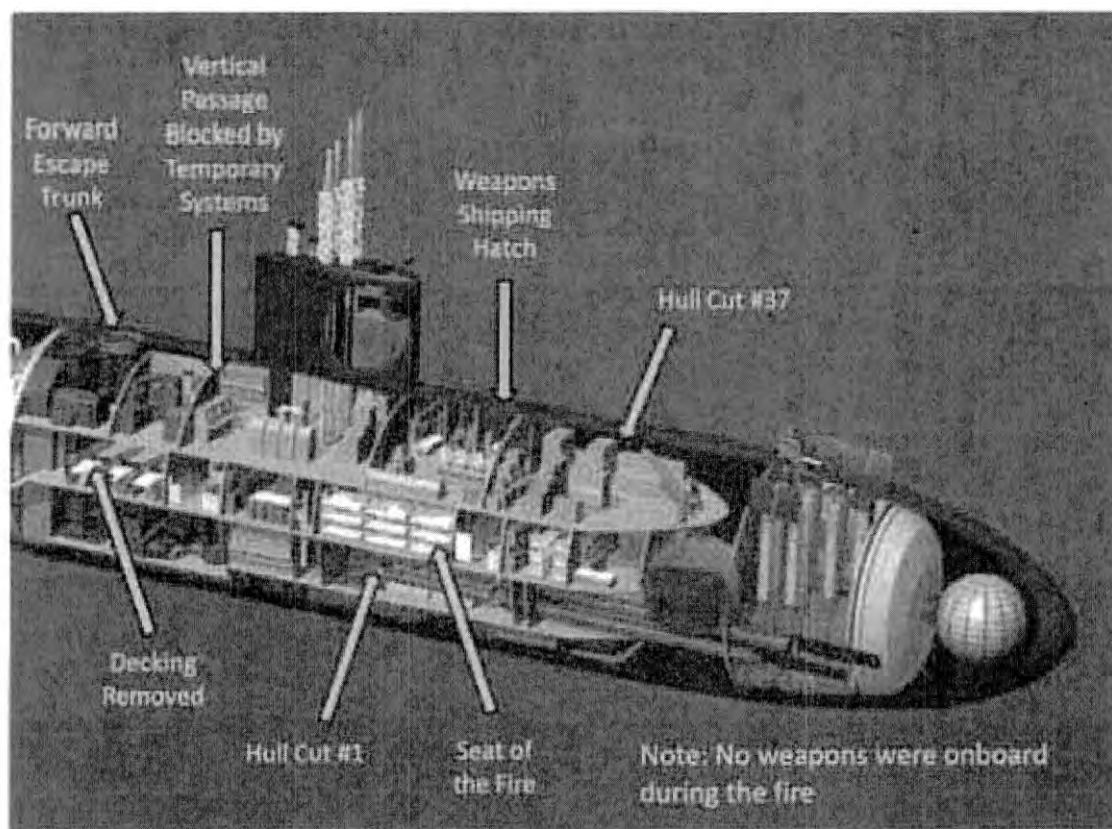
Figure 5: Location of Hull Cuts and Hatches

3.3.1.1. The placement and number of hull cuts can contribute to the severity of a fire. Hull openings from hatches, torpedo tube outer doors, and temporary hull cuts provided a continuous source of air introduction to the MIAMI fire which compounded the effort required to extinguish it. These hull openings had no in-place temporary closure capability which challenged DC teams while fighting the casualty.

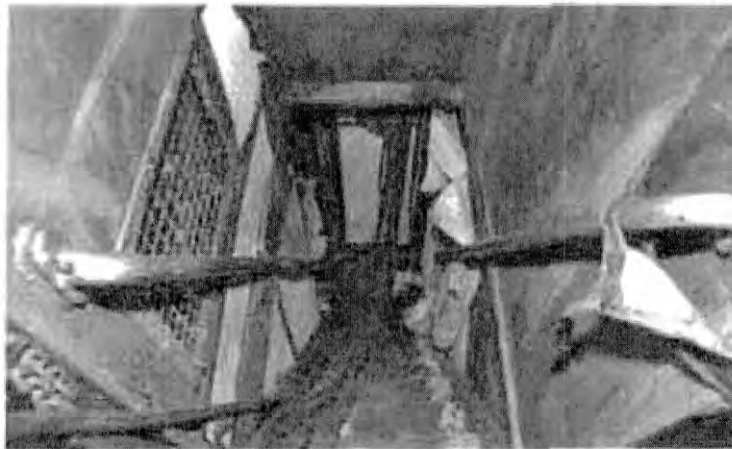
Fire hose and temporary services hinder access at FCML Ladder

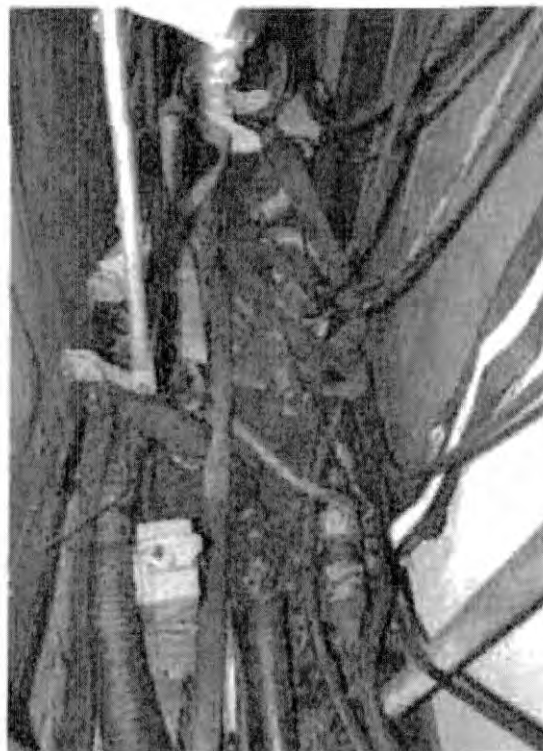
Damage control equipment and temporary services in Command Passageway

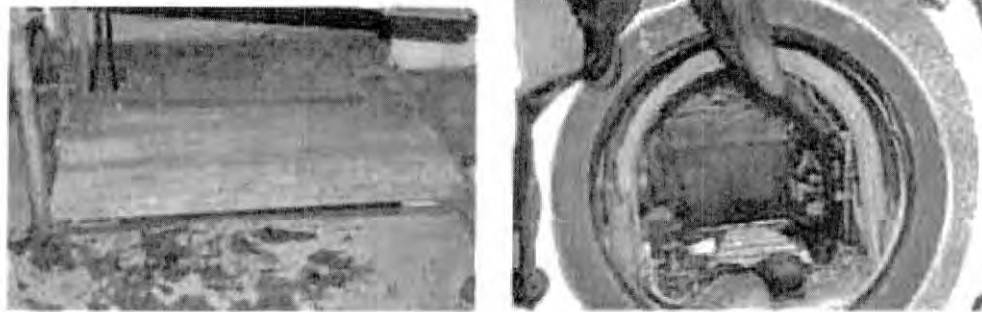
MIAMI Auxiliary Machinery Room scuttle temporary wood decking

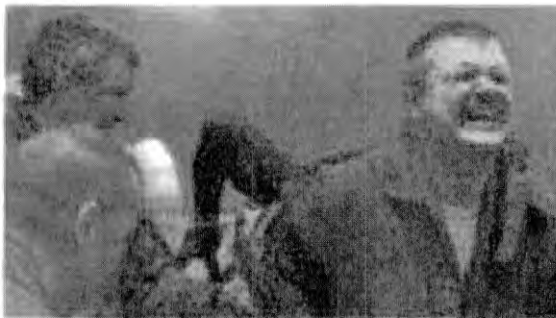
3.3.3.3. The FFE is inadequate to prevent steam burns near the head, face, and hands, and is not designed for high ambient temperatures. Although the FFE provides some personal protection in high temperature environments, its vulnerabilities were highlighted during both the MIAMI and GEORGE WASHINGTON fires. Some disparity exists between surface ship and submarine FFEs, primarily due to stowage and space considerations. For example, submarine FFEs do not include helmets or boots, instead utilizing fire retardant cloth fire hoods and personal foot wear. Submarine equipment limitations should be carefully reconsidered in the industrial environment, where the likelihood of fire is greater and off-hull DC equipment stowage lockers are available. Modern fire helmets with stackable storage configuration are sufficiently compact for the underway submarine environment.^{340,341} In the MIAMI fire, several instances of personal injury occurred due to scalding of the head and neck from fire hood wetting and subsequent steam formation. In the absence of firefighting helmets, there was little to protect the fire responders in the high temperature environment. Fire gloves were also inadequate against steam burning, becoming soaked from firefighting water and then subject to steam flashing.^{342,343} Firefighting suits offer some protection, but are not designed for sustainment in excessive heat environments, limiting their effectiveness.³⁴⁴

Limitations of PPE

"Only moments after entering the space to battle the blaze (on board training/test ship ex-USS Shadwell), the fire team was forced to retreat due to the heat. Sweat-soaked PPE exposed to the 754-degree temperatures within the space began to "boil" the men's skin. Once outside, safety observers quickly peeled away the steaming gear."
